**Flood Control Project Maintenance
Levee Inspections**
LMA District Cover Sheet
Spring 2017 Levee Inspection Results

Reclamation District No. 0554 Walnut Grove

Spring 2017 Levee Inspection Results

Waterway			Bank	Unit Miles
Unit No. 01 Sacramento River			Left	1.13
	Spring (March - May)	Summer (June - August)	(September - November) Fall	Winter (December - February)
Unit Maintenance Rating (Fall Only)				
Date of Inspection	4/18/2017 - 4/18/2017			
DWR Inspector	Herman Phillips			
Accompanied By	Gilbert Labrie

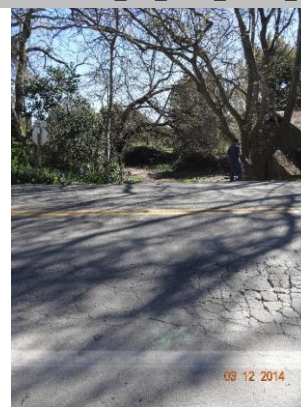
Photo 2 of 3 : UCIP_SP_2017_32021_58474.jpg

LM Start	0.89	Rating **	M	Issue No.	51 (cont)
LM End	0.89	Issue Type +	En	Location *	LS

View of levee crown.

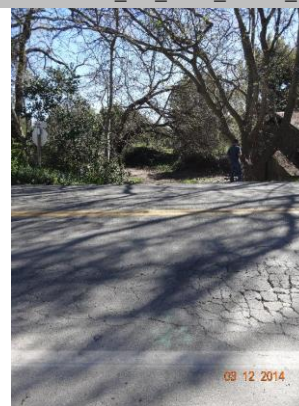
Photo 2 of 3 : UCIP_SP_2017_32022_58479.jpg

LM Start	0.89	Rating **	M	Issue No.	52 (cont)	
LM End	0.89	Issue Type +	En	Location *	LS	
Category	Supplemental			GPS Latitude/Longitude		
				Start	End	
Item	DWR UCIP Field Study			38.238595 °	38.238595 °	
				-121.516945 °	-121.516945 °	
DWR ID						
Comment Code						
Inspector Comment						
FS_ID:32022 DS_ID:20942 EP_NO: N/A Repair Type: Non-Urgent Crossing Status: Indicator Found UCIP Comments: Unable to confirm how many sewer lines cross levee. Desk study shows 2 crossings 4-inch not 6 inch. Need to contact owner to confirm status of crossing. FIELD_STRUCT_DESC: 2 of 2: 4-inch clay sewer pipe through the levee, 10.2 feet below the crown. (USACE-1959). This entry matches the Drainage or Irrigation Structure referenced in O&M manual (RM 26.50). FS Date: 3/12/2014

View of levee crown.
